# UNDERWATER BRIDGE INSPECTION REPORT

STRUCTURE NO. 30507

CSAH NO. 5

RUM RIVER

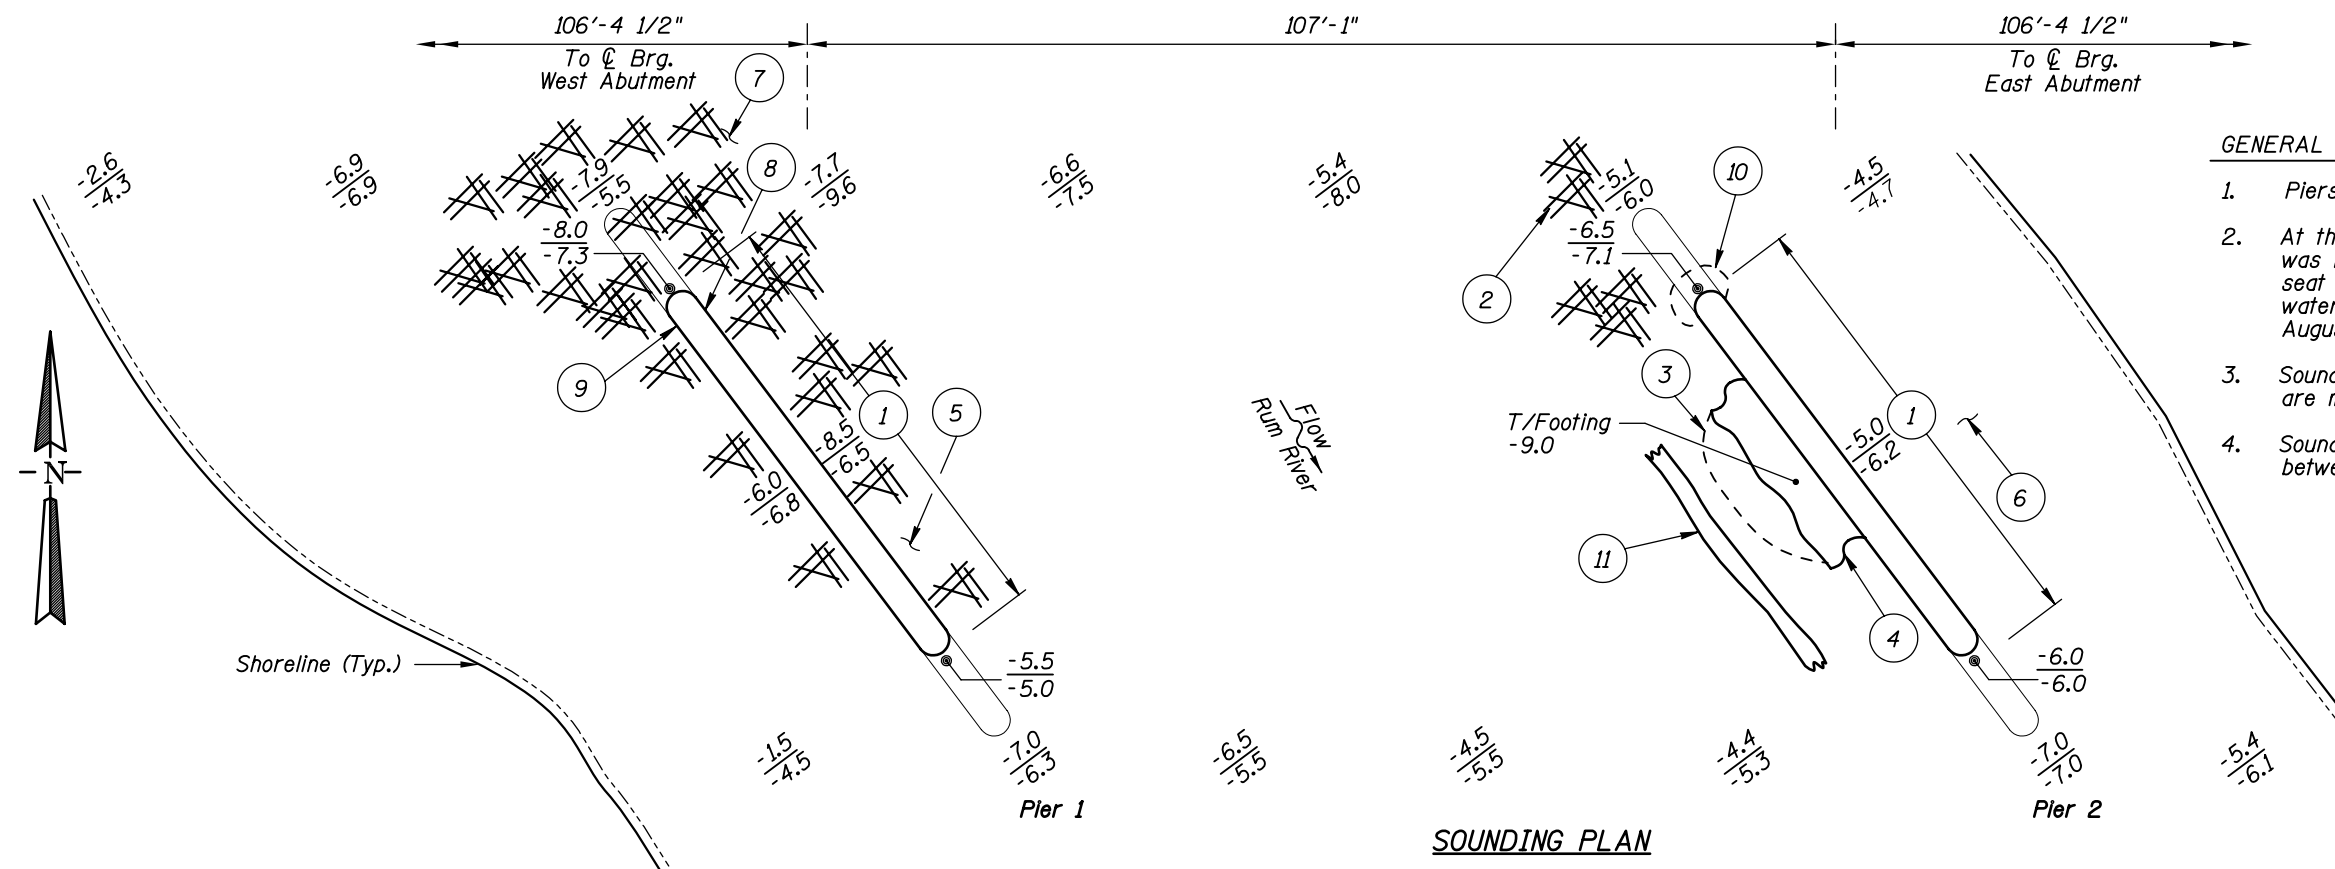
#### INSPECTION AND SOUNDING PLAN

1. All concrete surfaces from the waterline to the channel bottom exhibited light scaling with random pockets of poor consolidation with typical penetrations of 1/8 to 1/4 inch.

2. A light accumulation of timber debris was observed on the channel bottom extending 10 feet upstream of the upstream nose.
3. A 5-foot-radius, 4-foot-deep scour pocket was observed along the west side of Pier 2. The channel bottom at this location consisted of sand with 3" of probe rod penetration.

4. The top of the footing was exposed along the west side of Pier 2 for approximately 1/3 of the pier length with no vertical face exposure.
5. The channel bottom consisted of silty sand with 12 inches of probe rod penetration.

6. The channel bottom consisted of 1-foot-diameter riprap with some sand and gravel.
7. A moderate accumulation of 8-inch-diameter and smaller timber debris was observed at the upstream nose and along both faces of Pier 1.

8. A 1.5-foot-wide, 1-foot-high spall was observed 10 feet from the upstream nose just below the waterline, with a penetration of 1 inch and exposed reinforcing steel.

9. A 2-foot-long area of moderate to heavy scaling was observed at the upstream nose of Pier 1 extending 10 inches above the waterline to 1 foot below the waterline with a penetration of 1/2 inch.

10. A 2-foot-radius, 1.5-foot-deep scour pocket was observed at the upstream end of Pier 2.
11. A 4-foot-diameter log was observed on the channel bottom.

- (A) Remove the timber drift that has accumulated around the piers, especially the 4-foot-diameter log on the channel bottom, which may be influencing the scour and footing exposure along the mid portion of Pier 2.
- (B) Reinspect the submerged substructure units at the normal maximum recommended (NBIS) interval of five (5) years. Continue to monitor the footing exposure at Pier 2 during future inspections.

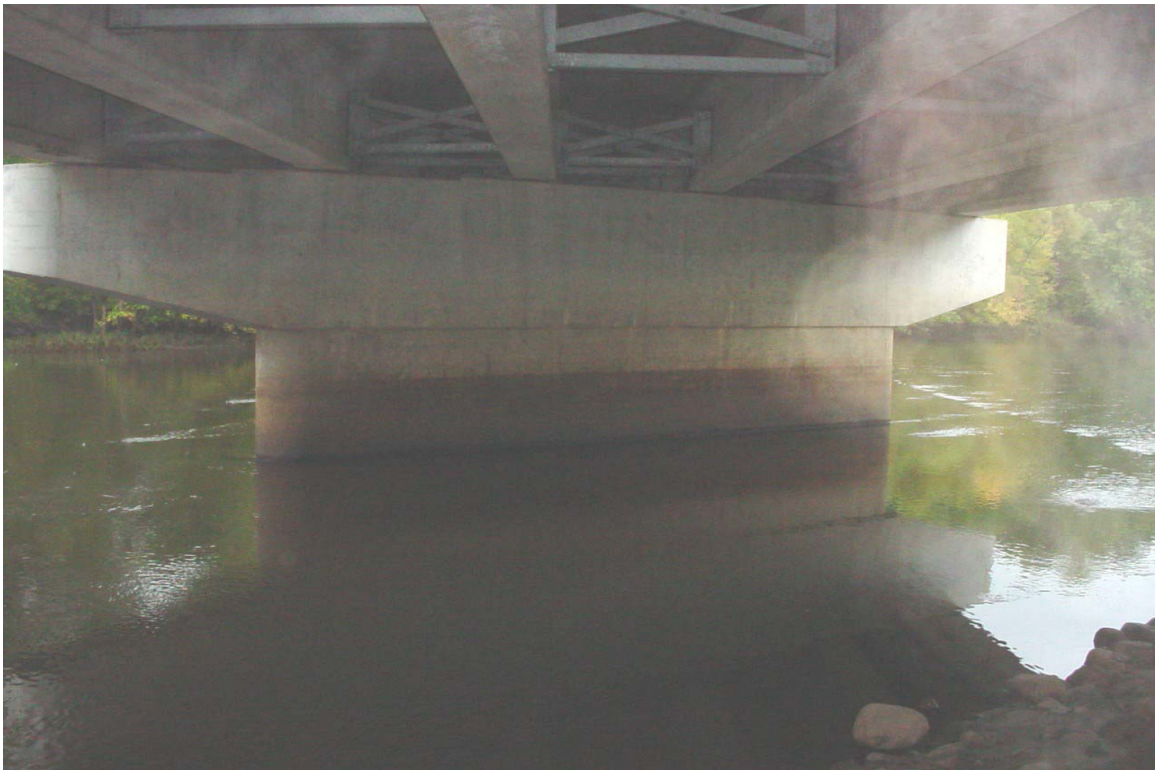
- (D) A moderate accumulation of 8-inch-diameter and smaller timber debris was observed at the upstream nose and along both faces of Pier 1. There was also a light accumulation of debris at the upstream end of Pier 2, and a 4-foot-diameter log on the channel bottom along the west face of Pier 2.

Photograph 2. View of Pier 1, Looking East.

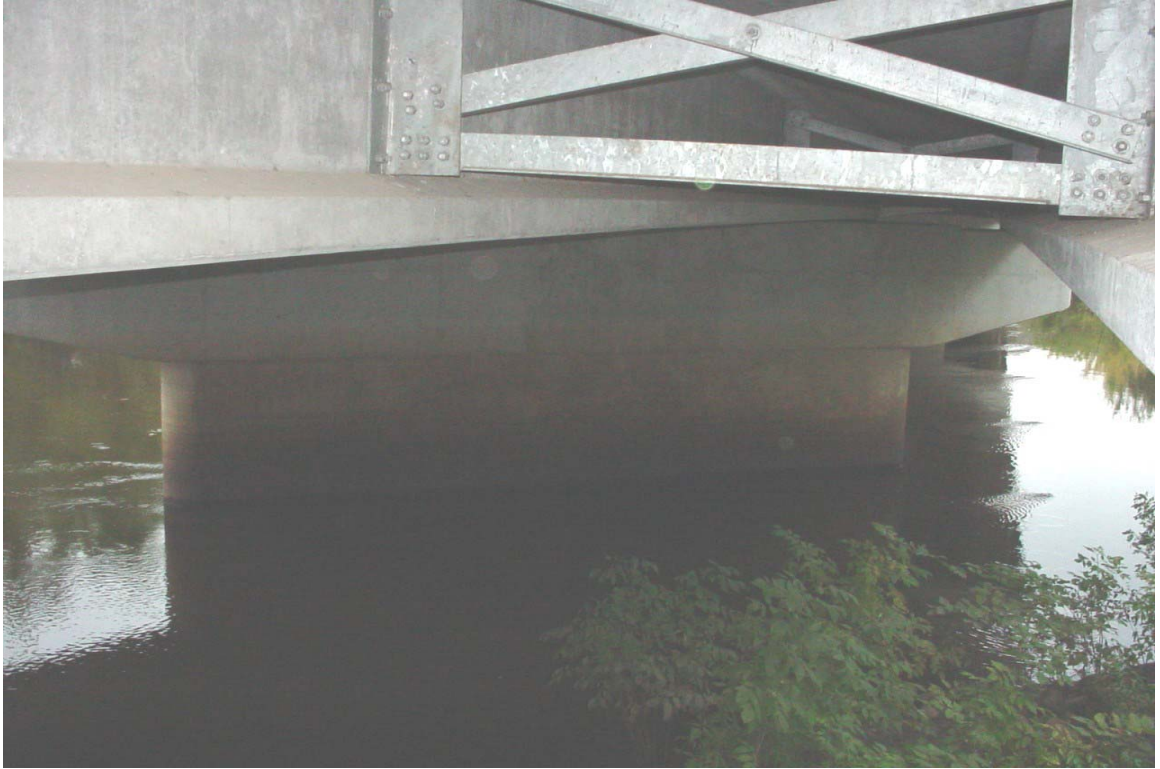
- (A) A 5-foot-radius by 4-foot-deep scour depression exposed the top of the footing along the west side mid portion of Pier 2 for approximately 20 feet with no edge or vertical face exposure. A 2-foot-radius by 1.5-foot-deep scour depression was also observed at the upstream end of Pier 2.
- (B) A 1.5-foot-wide by 1-foot-high spall was observed 10 feet from the upstream nose just below the waterline with a penetration of 1 inch and exposed reinforcing steel on the east side of Pier 1, and a 2-foot-long area of moderate to heavy scaling was observed on the west side of the pier extending 10 inches above the waterline to 1 foot below the waterline with a penetration of 1/2 inch.
- (C) All concrete surfaces from the waterline to the channel bottom exhibited light scaling with random pockets of poor consolidation with typical penetrations of 1/8 to 1/4 inch.

Photograph 3. View of Pier 2, Looking West.

Remove the timber drift that has accumulated around the piers, especially the 4-foot-diameter log on the channel bottom, which may be influencing the scour and footing exposure along the mid portion of Pier 2.

Reinspect the submerged substructure units at the normal maximum recommended (NBIS) interval of five (5) years. Continue to monitor the footing exposure at Pier 2 during future inspections.
